Dokorder, Inc.

SERVICE BULLETIN

SUBJECT: Model 1140 Replacement Circuit Board for
OUT OF WARRANTY REPAIR

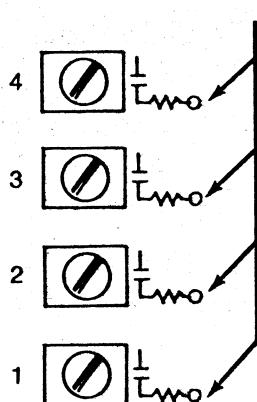
Connect probe here on 10 ohm resistor, one at a time.

1. Load unit with tape, bias in fixed mode, unit in record, pause on, multi-sync off, all channels in record.
2. With VTVM or scope, adjust bias trap coils for minimum reading (see below).

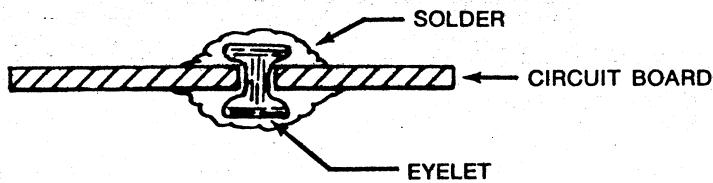
The intermittent connectios are the result of poor contact of an "eyelet" used to connect both sides of the circuit board (see below) to the solder.

Rather than repair the intermittent board, we are asking that you replace all boards as per the following instructions.
